Docket No. 217 – Development and Management Plan Inspection

Northeast Utilities Service Company Certificate of Environmental Compatibility and Public Need for the construction of a 345-kV electric transmission line and reconstruction of an existing 115-kV electric transmission line between Connecticut Light and Power Company's Plumtree Substation in Bethel, through the towns of Redding, Weston, and Wilton, and to the Norwalk Substation in Norwalk, Connecticut.

Date: September 29, 2006

Location: Transition Stations: Hoyts Hill, Archers Lane, Norwalk Junction

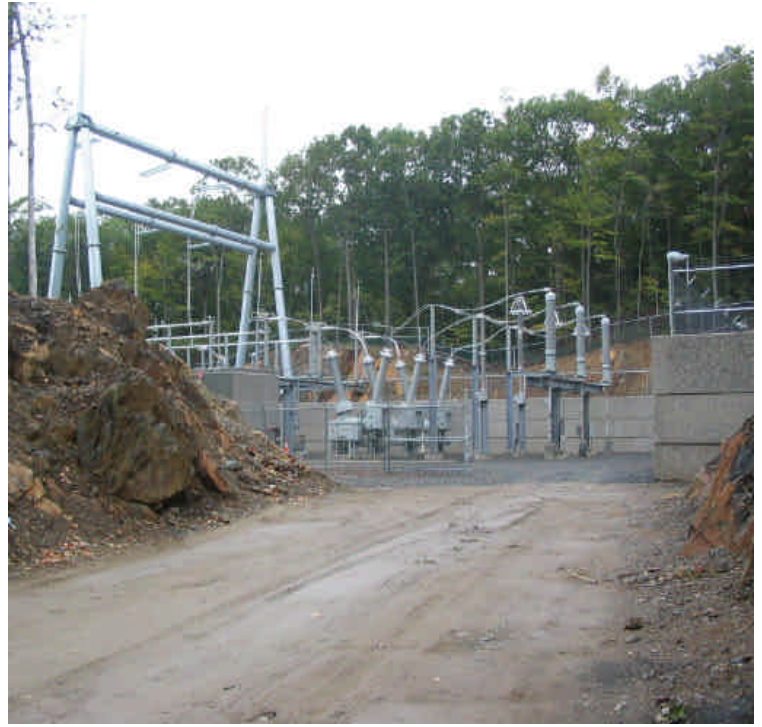
Archers Lane: Photo on the left shows some remaining stockpiles and bare slopes along the access drive. These areas should be restored/vegetated to the extent feasible. Photo on the right shows an overview of the yard. The line and stations will be energized soon. 9/29/06

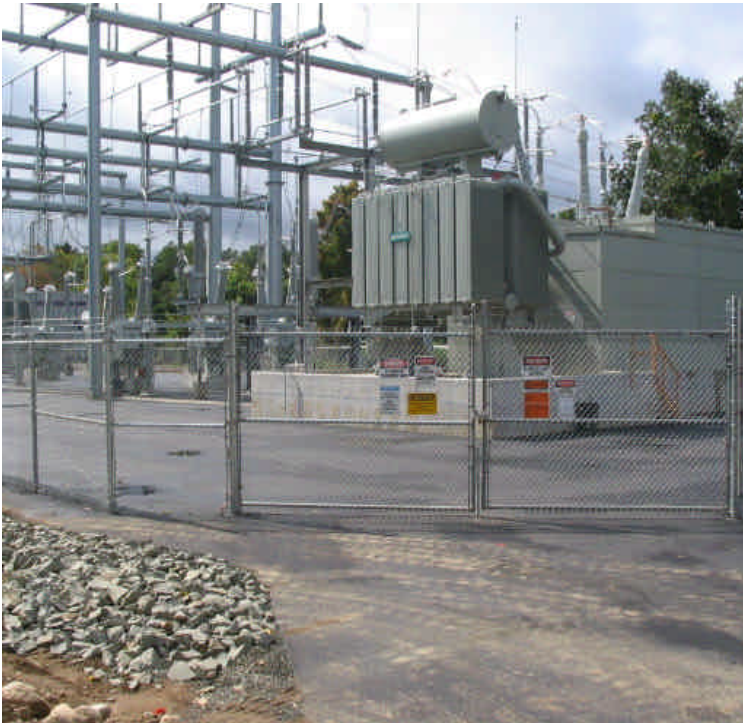
Norwalk Junction: Photo on the left shows the view of the paved station yard and driveway with the perimeter fence in place. Photo on the right shows the reinforced area of the swale at the driveway crossing. 9/22/06.
